Manhole Inspection Summary

Manhole # S35U__009MH

Insp Date: **2/13/08 3:45 PM**

Location Address: **1602 olive st**

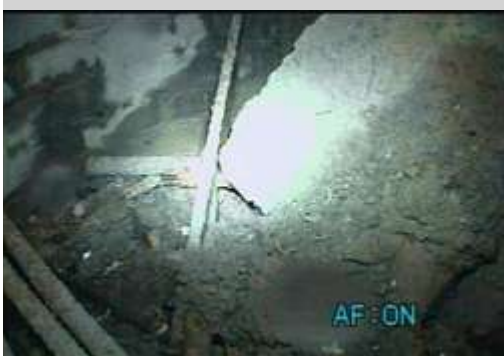
Defect 2

Comments **pipe not totally visible b/c of debris**

channel debris

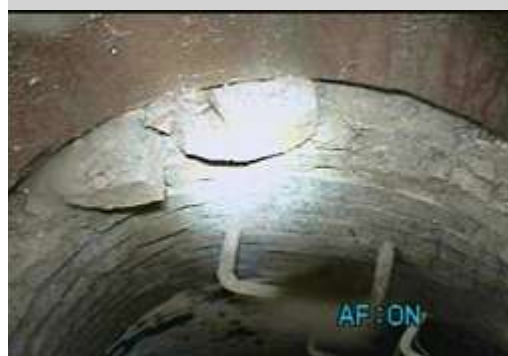
Defect 1

Offset: **1** (in.)

offset

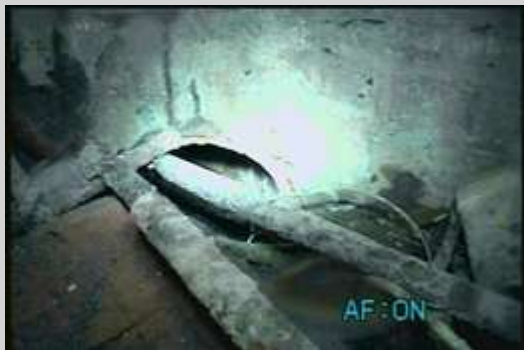
12 O'Clock Outflow

8 in. Circular Gravity Sewer
Pipe Out @ 12 O'Clock

Deposits: ☐ None ☐ Mud ☐ Sludge ☒ **Debris** ☐ Grease

Silt Depth: **3** (in.) Deposits Extent: **Medium**
